D-Day

TANK WARFARE

ARMORED COMBAT IN THE NORMANDY CAMPAIGN JUNE-AUGUST 1944

Steven J. Zaloga and George Balin

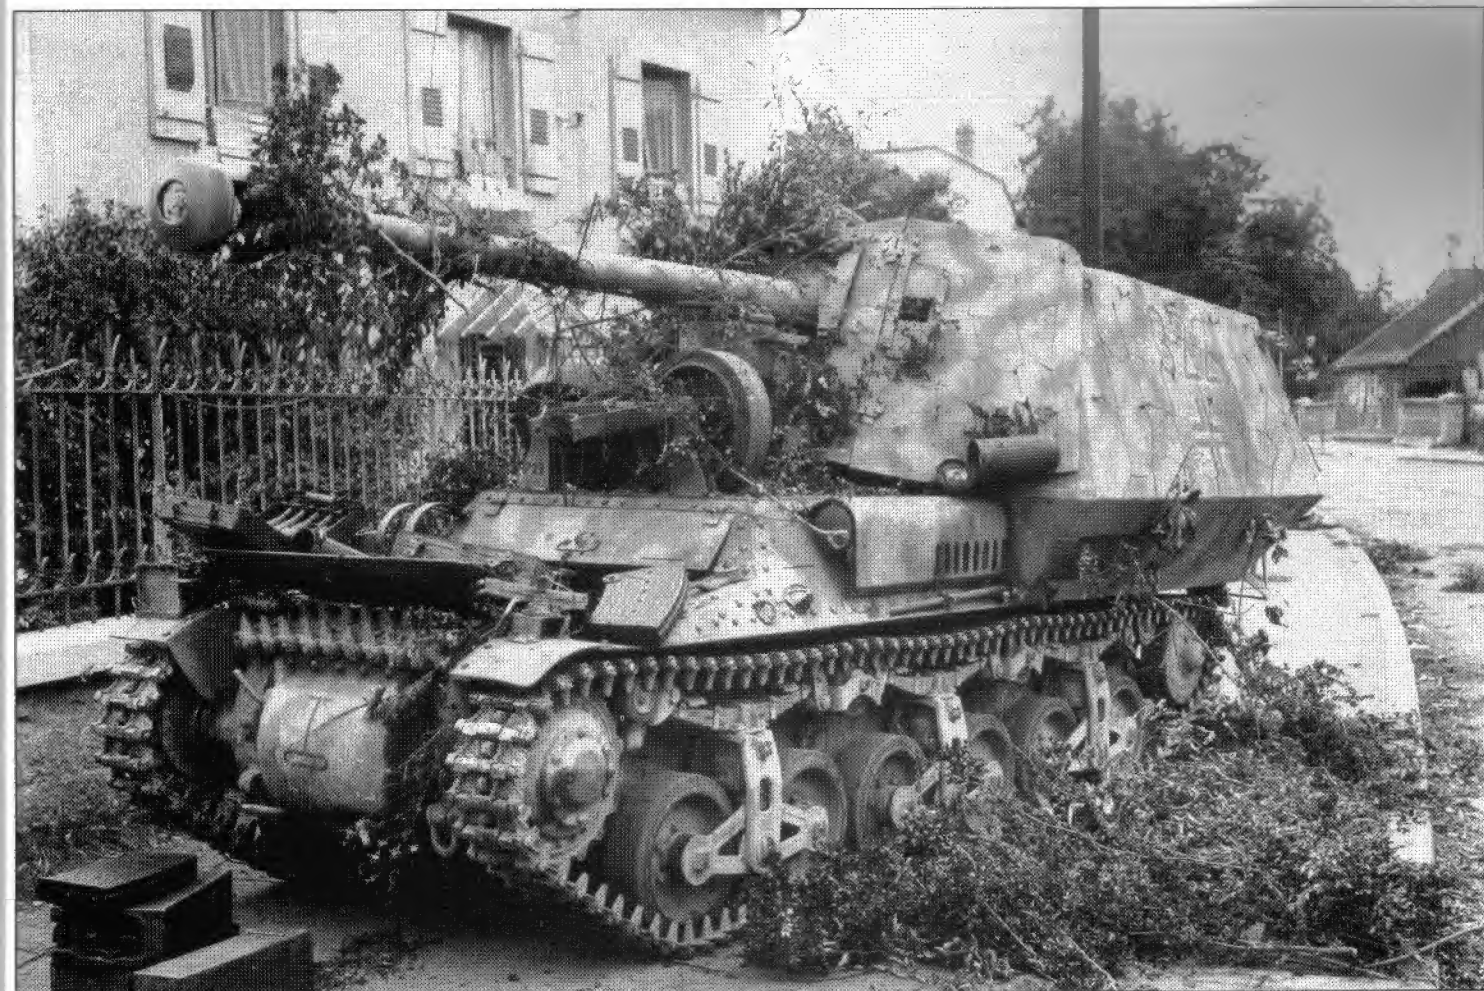
A 7.5cm PaK 40 auf Chenillette (f) lies abandoned in Vesoul, France. This was another of the Becker conversions, consisting of a German 75mm PaK 40 anti-tank gun mounted on a captured Chenillette Lorraine armored transporter. The Chenillette Lorraine was a popular basis for such conversions, as they were nearly all brand new in 1940, and many had not even been issued to French troops. (US Army)

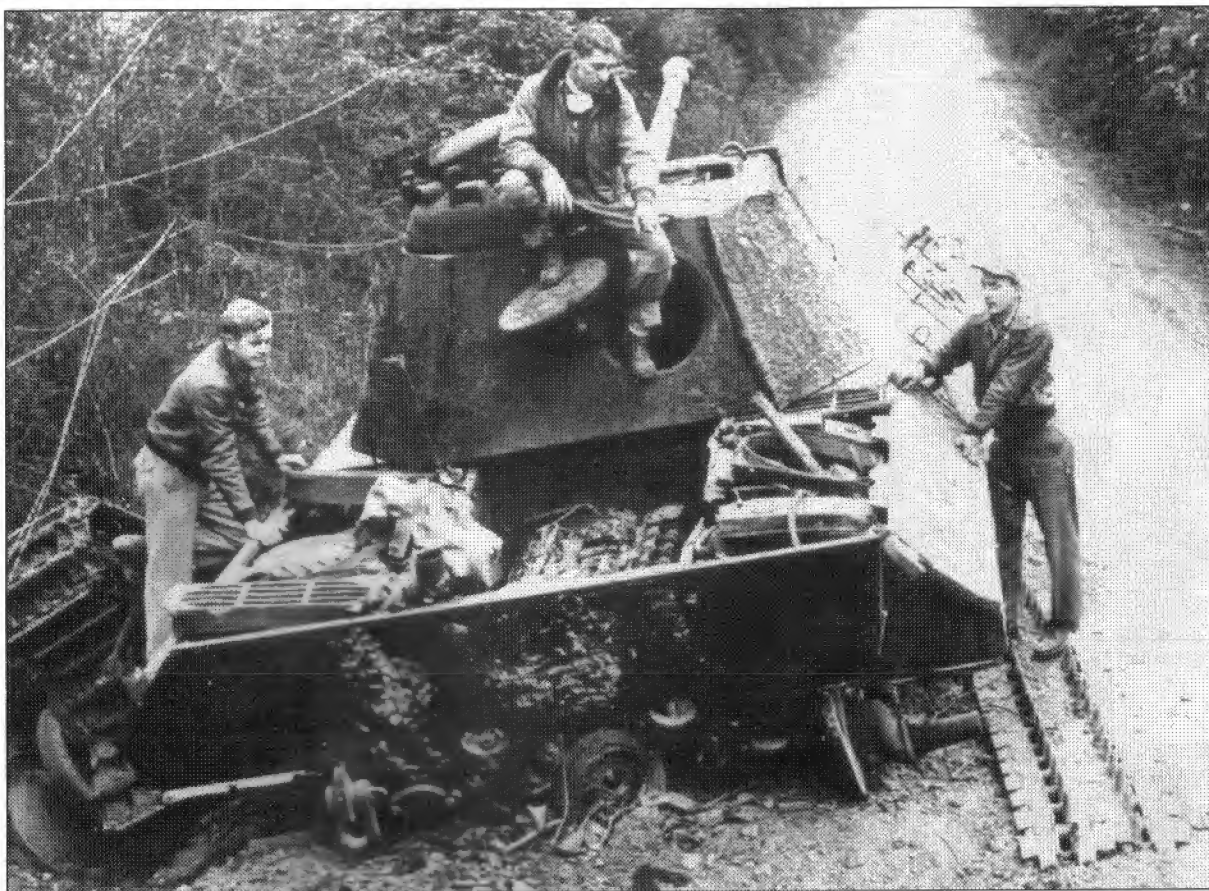
The Bergepanther was an armored recovery version of the Panther tank, fitted with a large winch in place of the turret. This abandoned Bergepanther captured by British forces is lacking the usual spade fitted at the rear, and was apparently being used in an improvised role as an ammunition carrier, hence the warning on the side of "Danger-H.E.". (The Tank Museum)

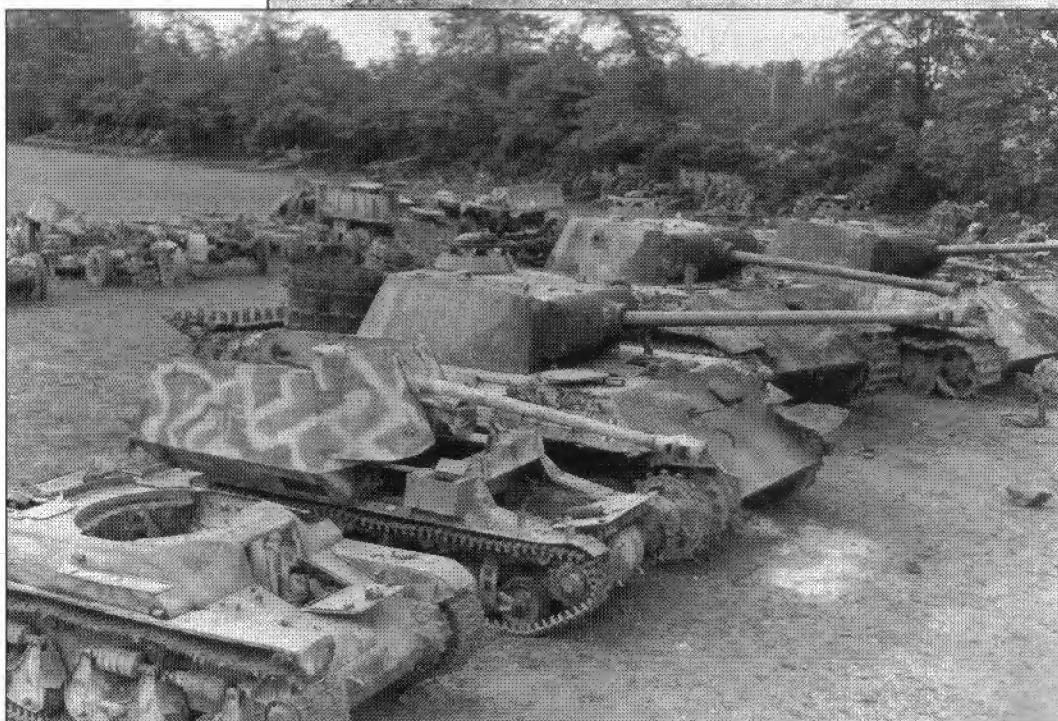
The US Army Ordnance set up a collection point for German armored vehicles for further technical inspection, this one being located south of Trevieres. To the left is a turretless French Renault 35.R, which from the fittings was formerly used as 4.7cm PaK (t) panzerjaeger. Beside it is a 7.5cm PaK 40 panzerjaeger on the Chenillette Lorraine chassis, and to the right are three Panthers. (US Army)

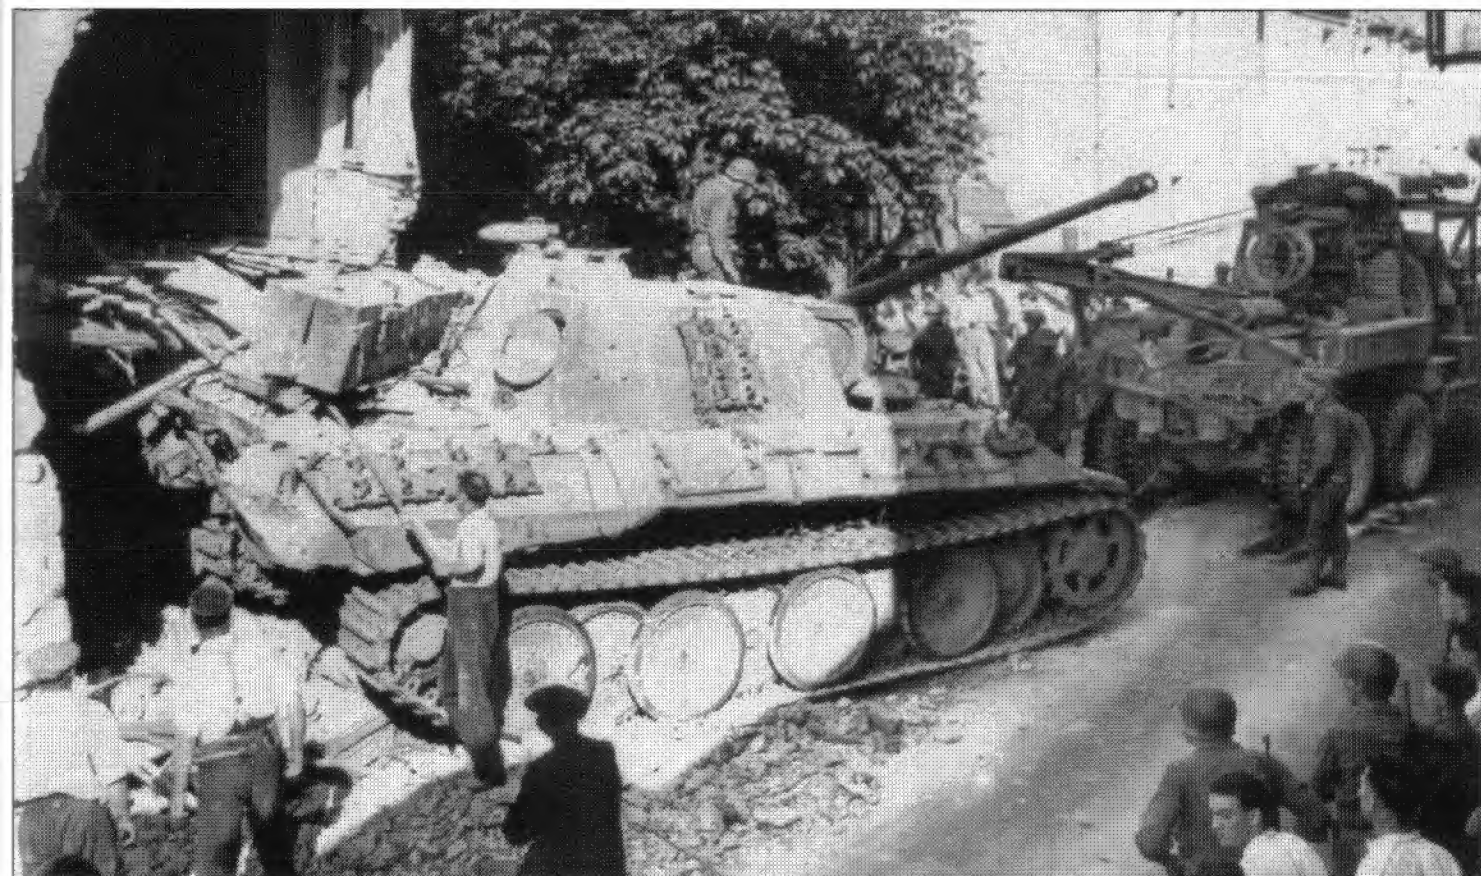
Troops of the French 2nd Armored Division recover a Panther Ausf. A tank that had come to grief in a small town near the Seine river in August 1944. The 2nd Armored Division landed in France in early August and was committed to the fighting in the middle of the month at the time of the battles around the Falaise Gap. (The Tank Museum)

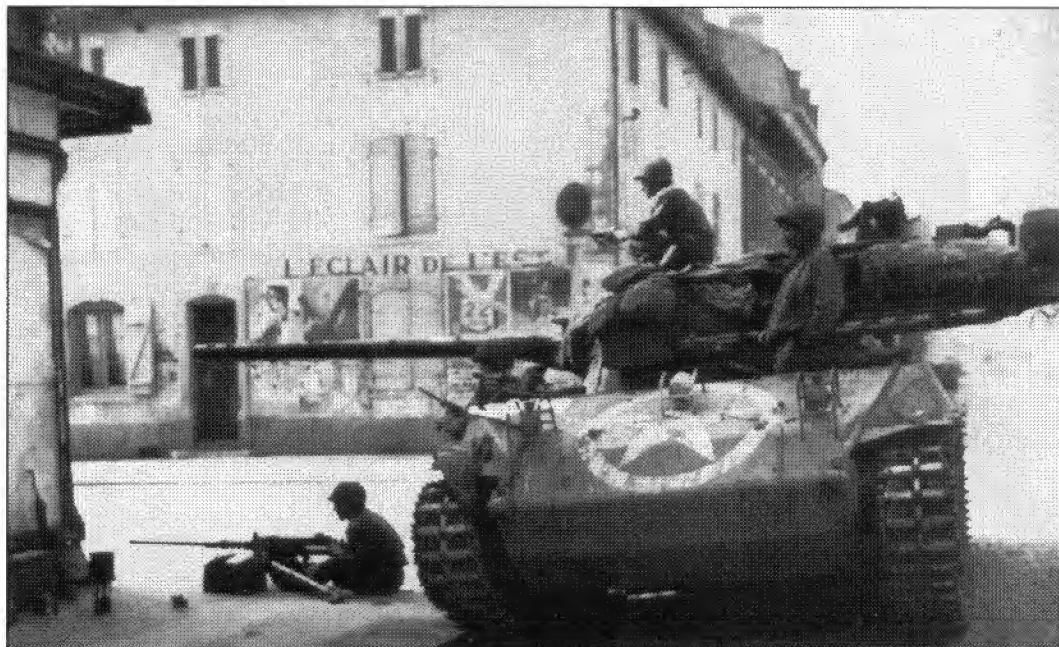
This M4A1 Duplex Drive has driven a long way since the landings at Normandy almost two months before. This is a very late production M4A1 with the 75mm gun, but featuring the revised hull with wet stowage. The Duplex Drive equipment has been almost completely removed, except for the power trains for the propellor at the rear. The tank has been draped with chicken wire to attach foliage for camouflage. (USS Intrepid Museum)

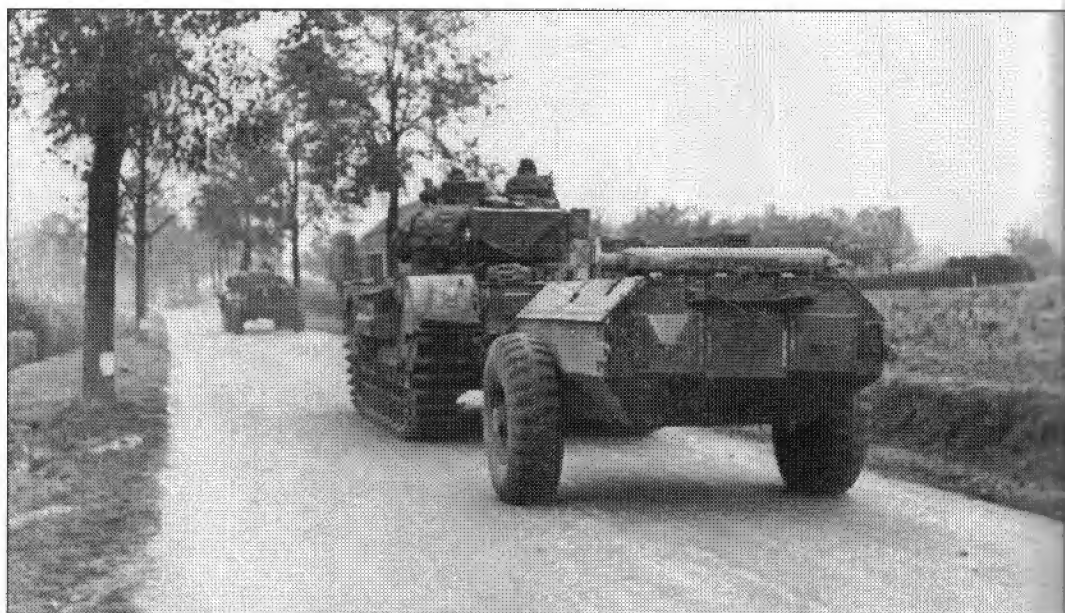
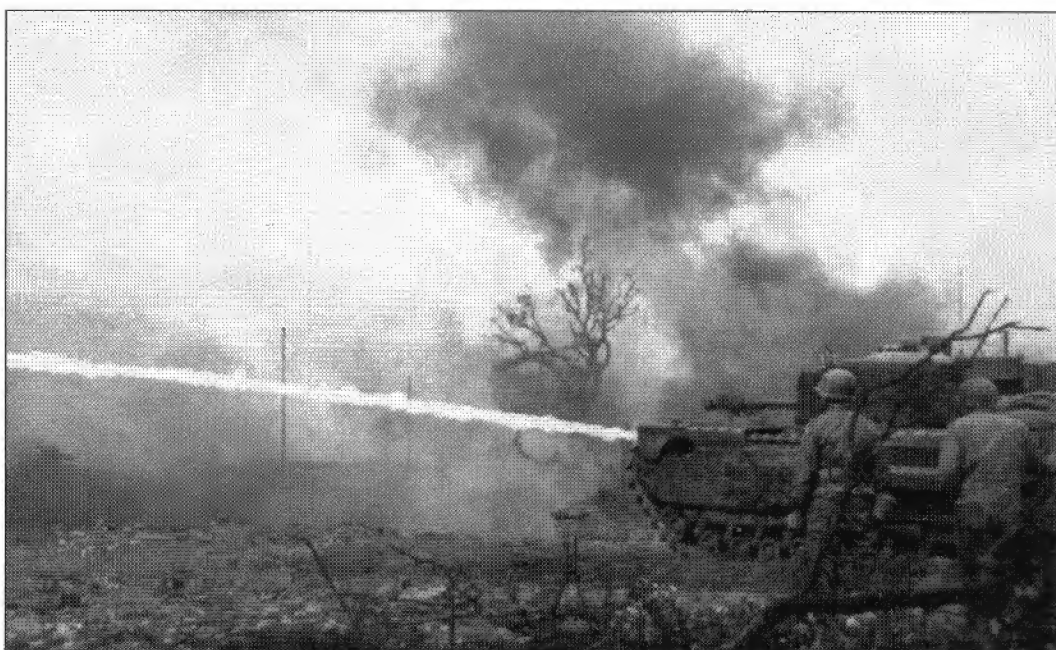
The Churchill Crocodiles were temporarily attached to a 4th Armored Division group trying to reduce German pockets of resistance in Brest. The Crocodile mounted a flamethrower in the glacis plate in place of the usual machine gun, and an armored trailer in the rear provided the fuel and pressurized air. (The Tank Museum)
